Linking the Physical Manifestation and Performance Effects of Injector Nozzle Deposits in Modern Diesel Engines

Alastair Smith and Rod Williams
Shell Global Solutions

CITATION: Smith, A. and Williams, R., "Linking the Physical Manifestation and Performance Effects of Injector Nozzle Deposits in Modern Diesel Engines," *SAE Int. J. Fuels Lubr.* 8(2):2015, doi:10.4271/2015-01-0892.

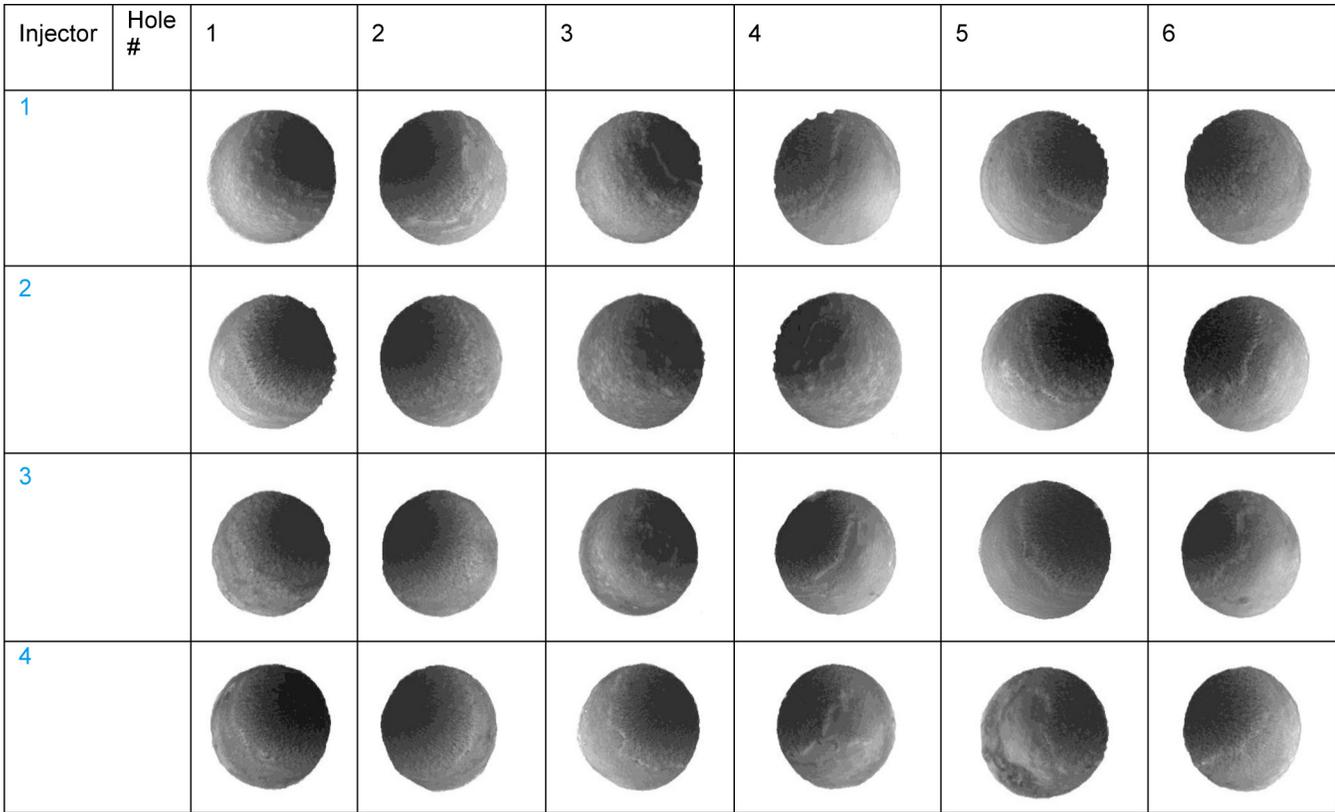
Figure 25. SEM images of injector nozzle deposits in the DW10B engine - after dirty-up

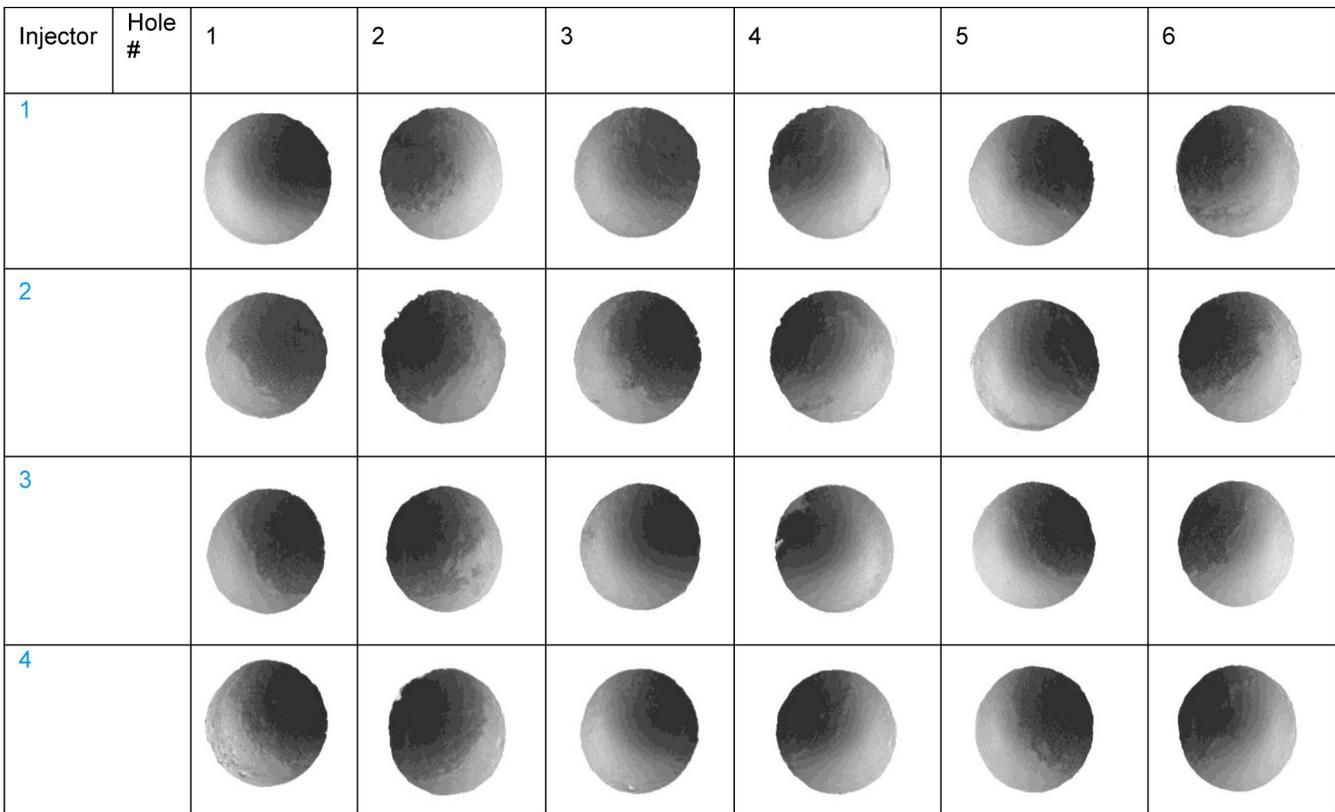
Figure 26. SEM images of injector nozzle deposits in the DW10B engine - after 3 hours/1-tank clean-up

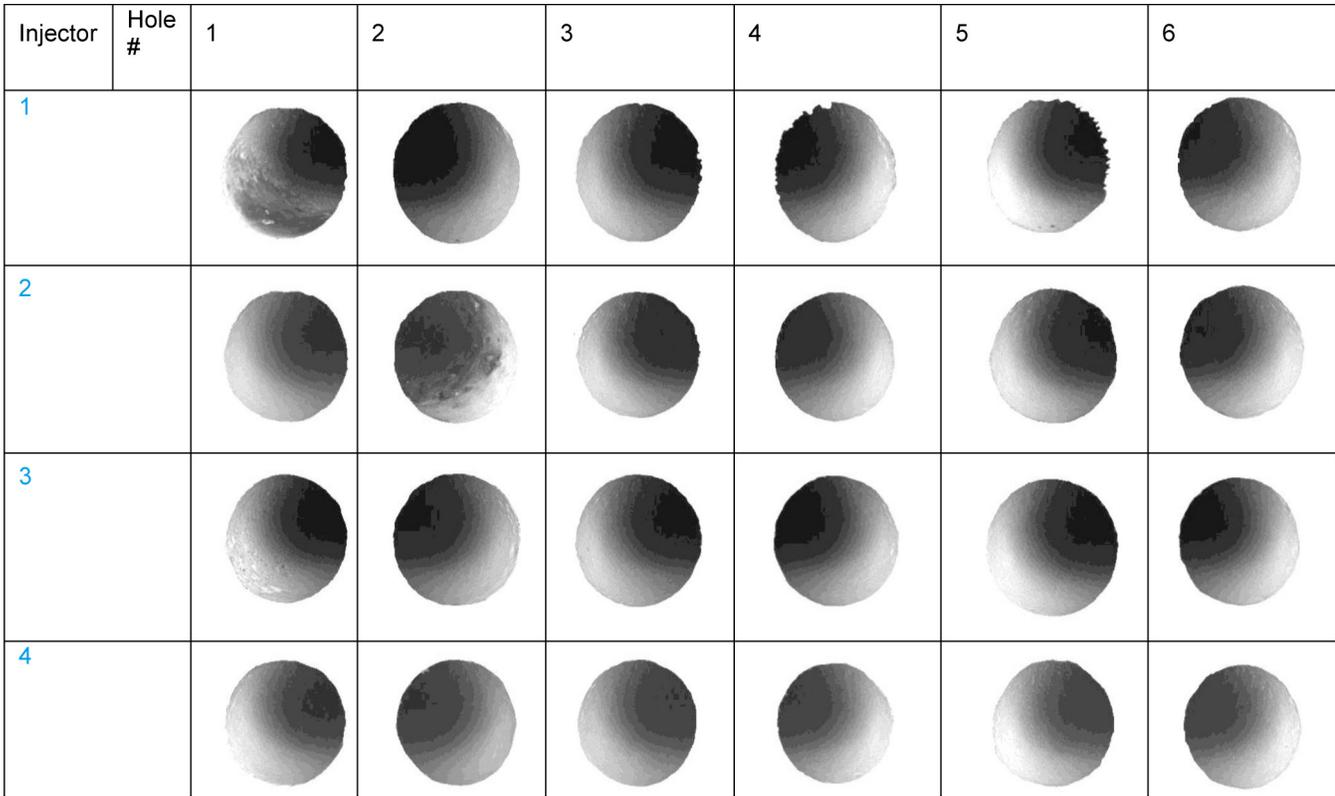
Figure 27. SEM images of injector nozzle deposits in the DW10B engine - at end of clean-up

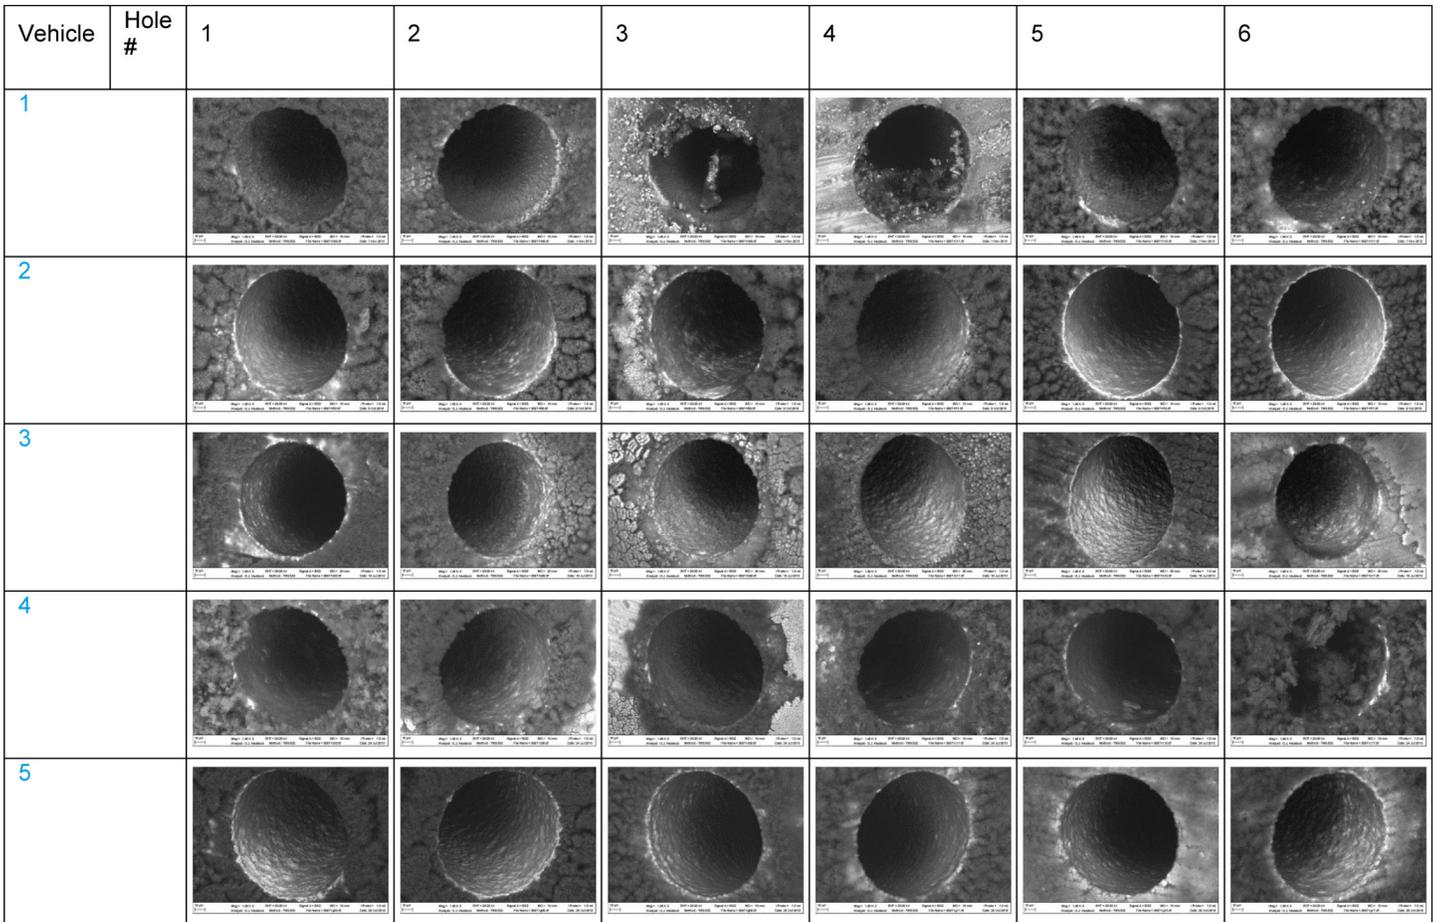
Figure 28. SEM images of injector nozzle deposits in the Euro5 vehicle fleet - after dirty-up (injector from cylinder 2, first 6 injector holes clockwise from datum)

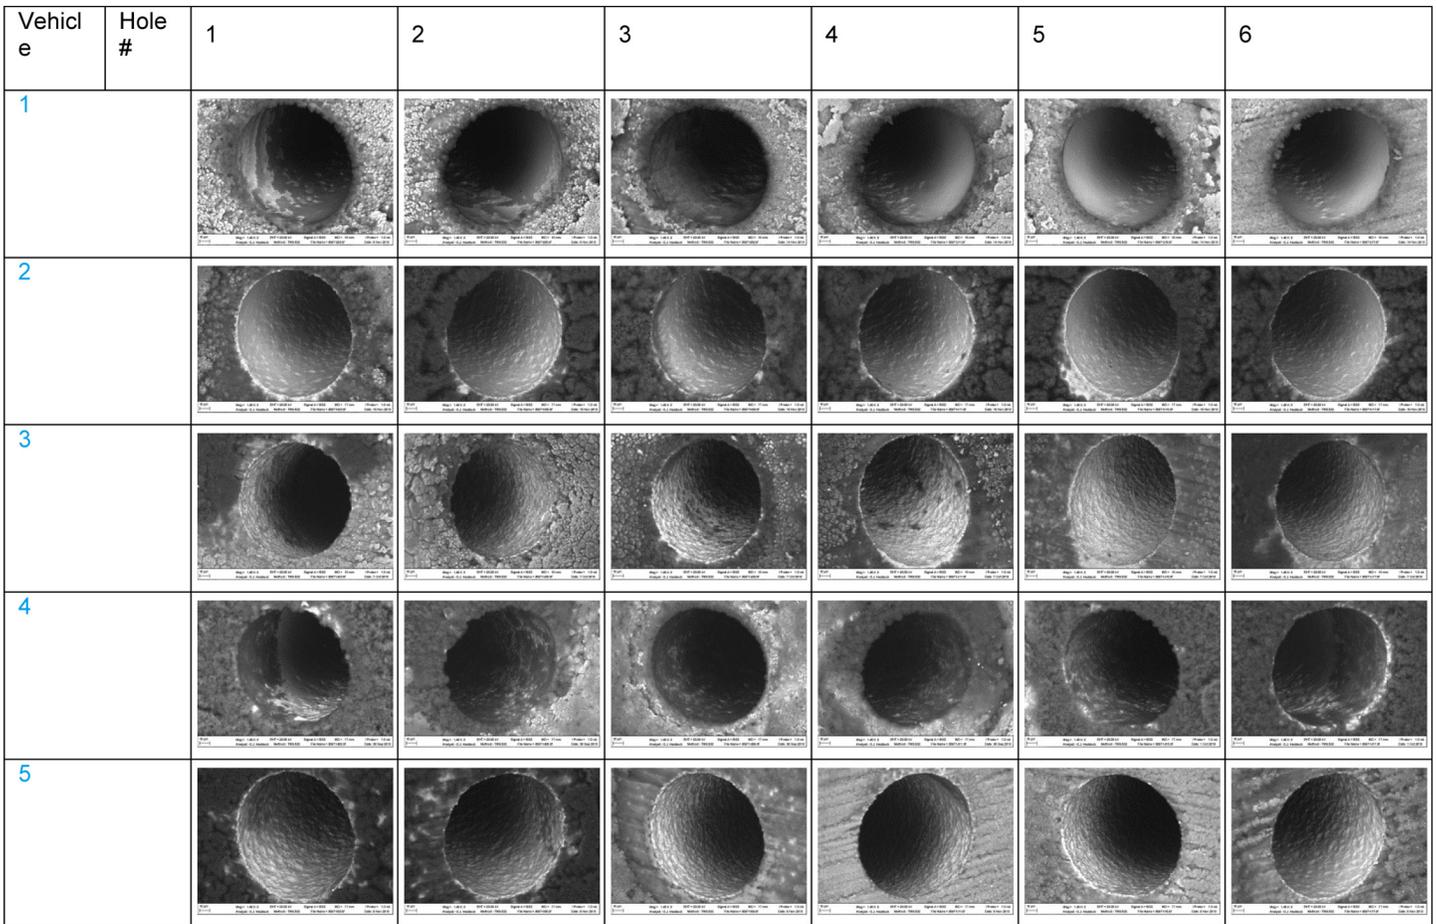
Figure 29. SEM images of injector nozzle deposits in the Euro5 vehicle fleet - after clean-up (injector from cylinder 2, first 6 injector holes clockwise from datum)
