Linking the Physical Manifestation and Performance Effects of Injector Nozzle Deposits in Modern Diesel Engines

Alastair Smith and Rod Williams
Shell Global Solutions

CITATION: Smith, A. and Williams, R., "Linking the Physical Manifestation and Performance Effects of Injector Nozzle Deposits in Modern Diesel Engines," *SAE Int. J. Fuels Lubr.* 8(2):2015, doi:10.4271/2015-01-0892.

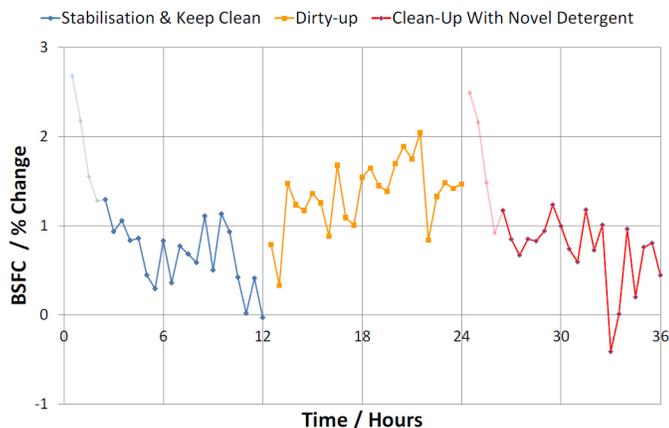
Figure 16. The fleet average % change in BSFC at maximum APP showing a tendency for worsening BSFC as deposits form and showing a tendency for BSFC to recover as deposits are removed. Faint lines show where BSFC was affected by vehicle thermal stabilisation.

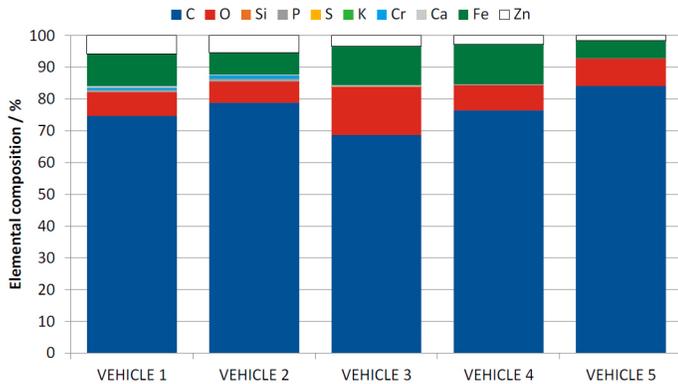
Figure 21. Average elemental composition of deposits analysed in-situ within fuel injector nozzle holes by EDX after dirty-up phase of test (weight % of analysed area - data tabulated in [appendix](#)). Note that the most abundant elements are C, O, Fe and Zn.

The tables and charts above show that the deposits formed during this study were predominantly made up of carbon, with other elements present in significant quantities.

- Zinc was present in all deposits measured. The majority of this would have come from the zinc neodecanoate dosed into the fuel as a pro-foulant, though a little may have come from burnt lubricant and pick up from vehicle fuel system materials.
- Calcium and Phosphorous were consistently present, albeit in small quantities, supporting the hypothesis that some elemental contamination of the deposits came from burnt lubricant.
- The proportion of carbon to metallic elements does not remain consistent between the dirty and cleaned injectors, though it is unclear as to the mechanism of any bias. Fe was detected in all samples, and is thought to be from the underlying injector metal substrate. The signal intensity may be linked to the deposit thickness.

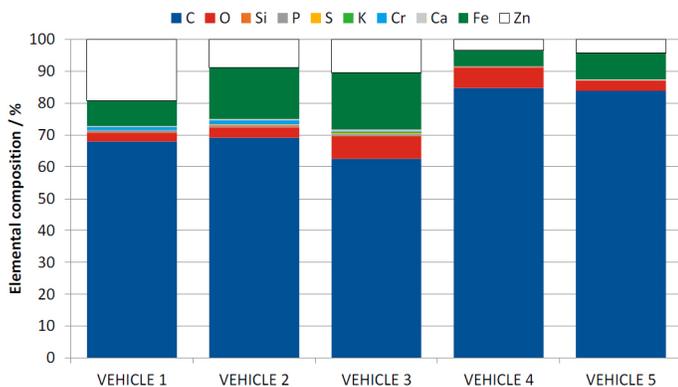
Figure 22. Average elemental composition of deposits analysed in-situ within fuel injector nozzle holes by EDX after clean-up phase of test (weight % of analysed area).

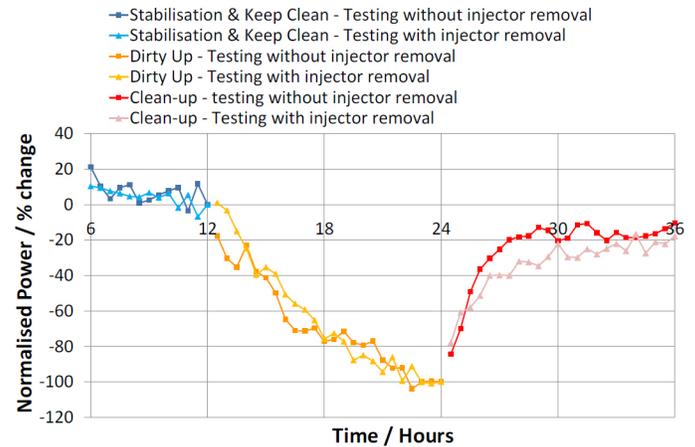
Figure 23. Change in power (%) in vehicle 1 - comparing power loss and recovery during previous work (squares, dark) with that of the current study (triangles).

Direct comparison between datasets for the current study and previous data [2] is possible by normalising the power change to the end of stabilisation. Figure 23 shows that the clean-up obtained when the injector was removed was slightly worse than in the continuous test during the initial phases of clean-up though the total percentage clean-up was comparable. This shows that removing and refitting the injector did not impose a positive bias on the clean-up result.

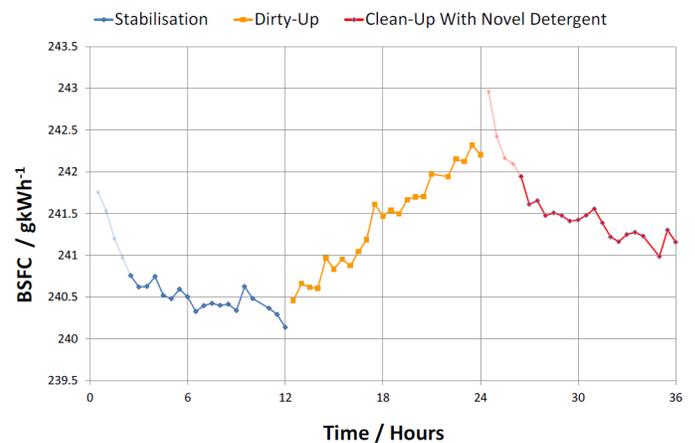
Figure 24. Change in BSFC at 80% load for Vehicle 1

Further investigation of the effect of interrupting the test for injector imaging entailed analysing the effect of this on BSFC. BSFC during the 80% load for this vehicle was chosen instead of the full load condition as it was less affected by DPF regeneration. Figure 24 shows that a comparable drop in BSFC was seen during the generation of the first few data points after both the initial start-up and the re-start following injector imaging. These data are illustrated in the figure by the data points with reduced colour intensity. This suggests that frictional losses in the vehicle engine and driveline reduce for the first two hours of running due to thermal stabilisation.

BSFC increases substantially as deposits form in vehicle 1 and decreases as deposits are removed. It should be noted that such a stark link between deposits and BSFC is not observed in all of the vehicles.
